A Guide to the Inspection of Existing Homes

for Wood-Inhabiting
Fungi and Insects

Michael P. Levi

Prepared as a part of interagency agreement IAA-25-75 between the USDA Forest Service and the Department of Housing and Urban Development.

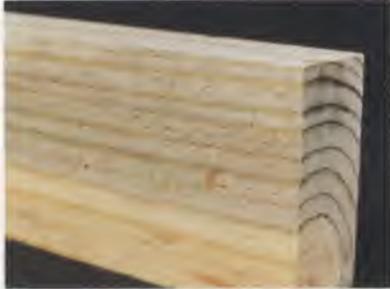
Figure 3. Sapstain fungi in pine sapwood

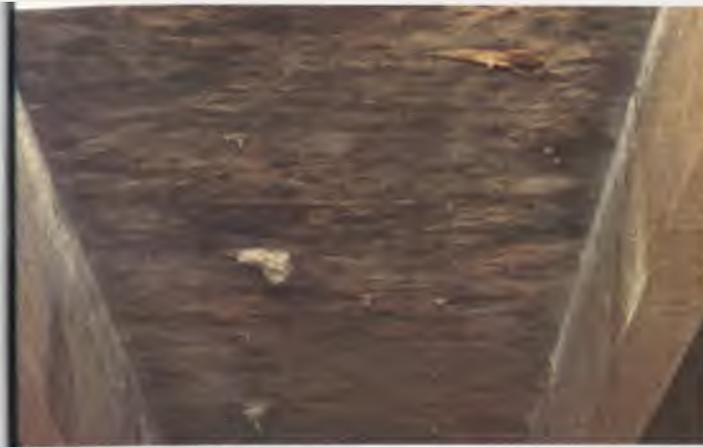
Figure 4. Surface molds on plywood in attic

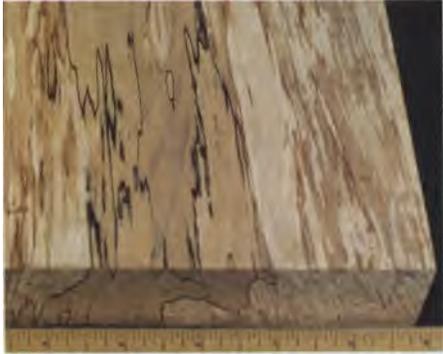
Figure 7. White rot, with black zone lines sometimes found in the early stages of decay

Wood decayed by white-rot fungi is fibrous and spongy, and is bleached in color. Sometimes it has thin, dark lines around decayed areas. The wood does not shrink until decay is advanced.

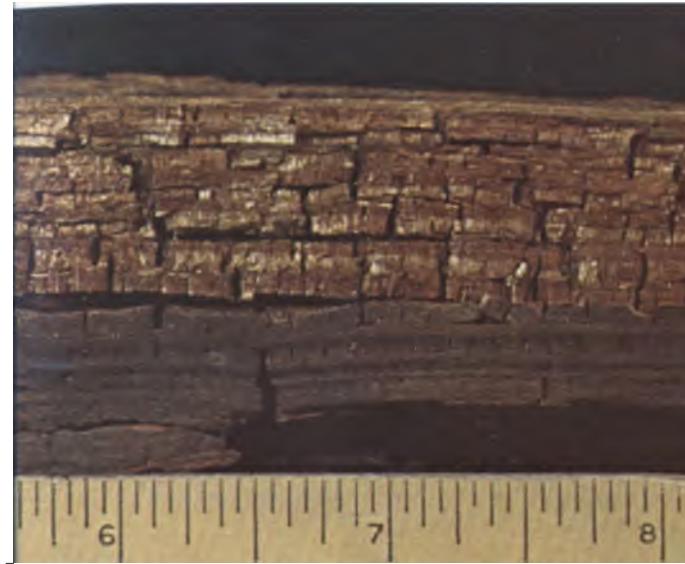
Figure 8. Brown rot, with characteristic cracks across grain

Wood decayed by brown-rot fungi is brittle and darkened in color. As decay proceeds, the wood shrinks, twists, and cracks perpendicular to the grain. Finally, it becomes dry and powdery. Brown rot is the commonest type of decay found in wood in houses.

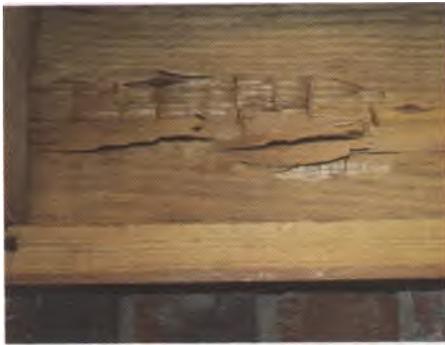
Figure 11. Wood damaged by *Poria*, with apparently sound surface and severe rot below surface

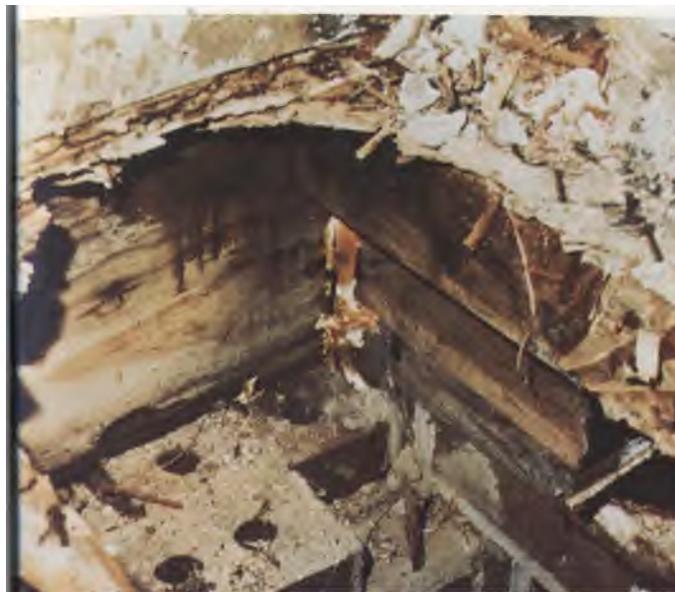
Figure 12. Rhizomorph of *Poria* growing from earth-filled porch

planters. Where the fungus grows from a porch, the soil should be removed from the porch next to the foundation wall to prevent continued growth of the fungus into the house. *Poria incrassata* normally occurs in new or remodeled houses and can cause extensive damage within 2 to 3 years.

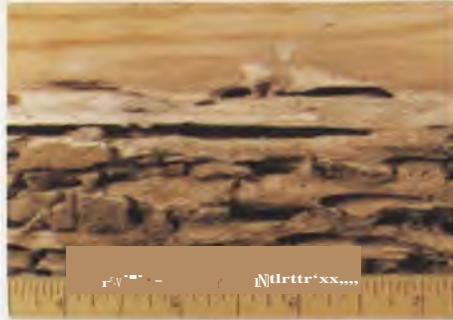
Figure 18A. Subterranean termite damage showing characteristic spotted appearance of the surface of the galleries, presence of soil in the damaged wood, and the preferential attack of the softer springwood

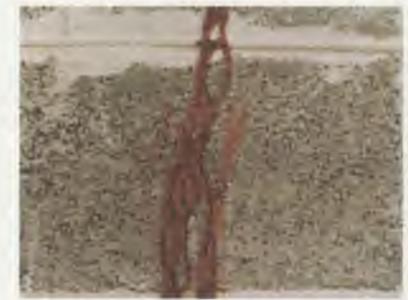
Figure 19. Subterranean termite shelter tubes on concrete block foundation wall

Subterranean termites normally damage the interior of wood structures. Shelter tubes are the commonest sign of their presence. Other signs include structural weakness of wood members, winged termites or swarmers, soil in cracks or crevices, and dark or blister-like areas on wood. The major characteristics of infested softwood when it is broken open are that damage is normally greatest in the softer springwood, and gallery walls and inner surfaces of shelter tubes have a pale, spotted appearance like dried oatmeal. The galleries often contain a mixture of soil and digested wood. Termites usually enter houses through wood in contact with the soil or by building shelter tubes on foundation walls, piers, chimneys, plumbing, weeds, etc.

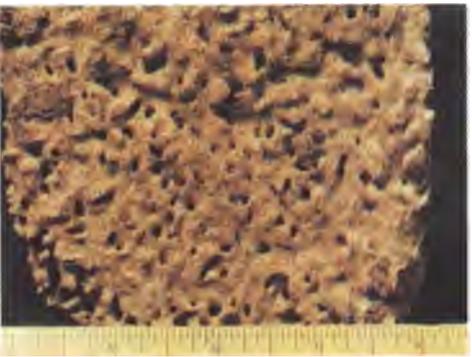
Figure 22. Carton produced between studs by Formosan subterranean termites

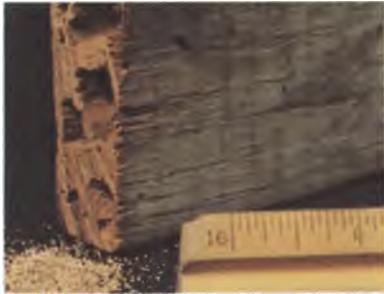
Figure 26. Drywood termite damage showing pellets, large chambers of galleries in the interior of wood, and small "kick-holes" on the surface

very little external evidence of drywood termite attack in wood other than the pellets. The interior of damaged wood has broad pockets or chambers which are connected by tunnels that cut across the grain through spring- and summerwood. The galleries are perfectly smooth and have few if any surface deposits. There are usually some fecal pellets stored in unused portions of the galleries. Swarming is another sign of termite presence.

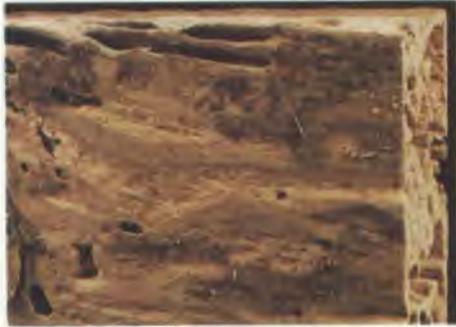
Figure 30A. Dampwood termite damage in one inch-thick board, showing some fecal pellets, the velvety appearance of the surface of the galleries, and the preferential attack of the softer springwood

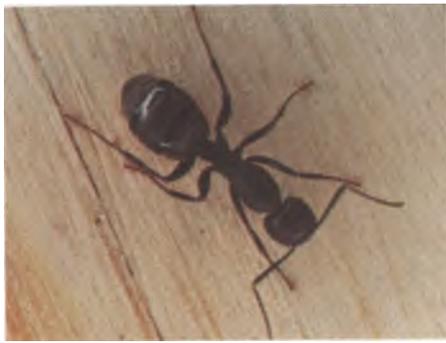
Figure 33A. Carpenter ant (approximate length 3/8 inch)

Larpernter ants burrow into wood to make nests, and do not feed on the wood. They commonly nest in dead portions of standing trees, stumps, logs and sometimes wood in houses. Normally they do not cause extensive structural damage. Most species start their nests in moist wood that has begun to decay. They attack hardwoods and softwoods. The most obvious sign of infestation is the large reddish-brown to black ants, 1/4 to 1/2 inch long, inside the house. Damage occurs in the interior of the wood. There may be piles or scattered bits of wood powder (frass) which are very fibrous and sawdust-like. If the frass is from decayed wood, pieces tend to be darker and more square ended. The frass is expelled from cracks and crevices, or from slit-like openings made in the wood by the ants. It is often found in basements, dark closets, attics, under porches, and in crawl spaces. Galleries in the wood extend along the grain and around the annual rings. The softer

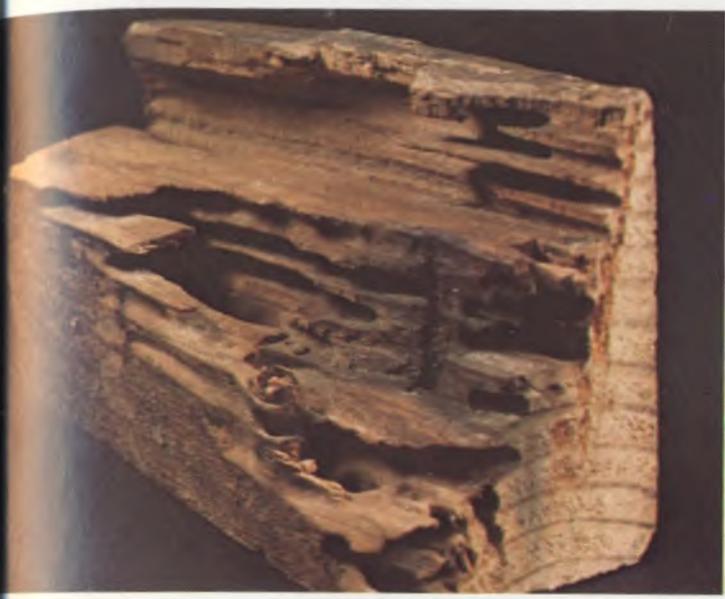
Figure 33B. Carpenter ant damage showing clean galleries with a smooth surface, the preferential attack the softer springwood, and some brown rot on end grain

springwood is removed first. The surfaces of the galleries are smooth, as if they had been sanded, and are clean. The most effective way to control carpenter ants is to locate the nest and kill the queen in colonies in and near the house with

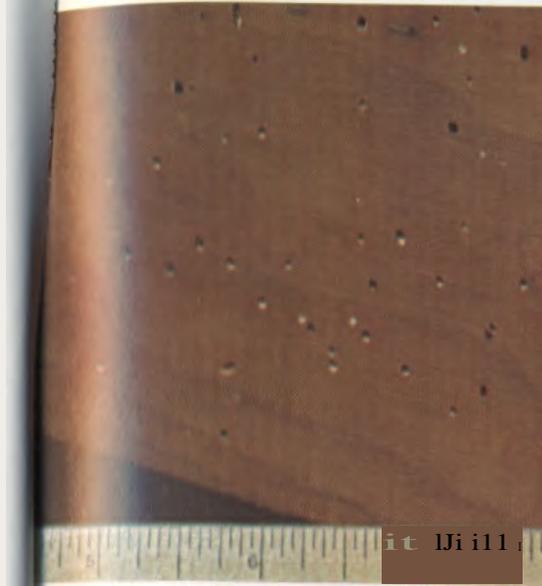
Lyctids attack only the sapwood of hardwoods with large pores: for example, oak, hickory, ash, walnut, pecan, and many tropical hardwoods. They reinfest seasoned wood until it disintegrates. Lyctids range from 1/8 to 1/4 inch in length and are reddish-brown to black. The presence of small piles of fine flour-like wood powder (frass) on or under the wood is the most obvious sign of infestation. Even a slight jarring of the wood makes the frass sift from the holes. There are no pellets. The exit holes are round and vary from 1/32 to 1/16 inch in diameter. Most of the tunnels are about 1/16 inch in diameter and loosely packed with fine frass. If damage is severe, the sapwood may be completely converted within a few years to frass held in by a very

Figure 36. Lyctid powderpost beetle damage with exit hole on surface and powder-filled galleries in the interior

thin veneer of surface wood with beetle exit holes. The amount of damage depends on the level of starch in the wood. Infestations are normally limited to hardwood paneling, trim, furniture, and flooring. Replacement or removal and fumigation of infested materials are

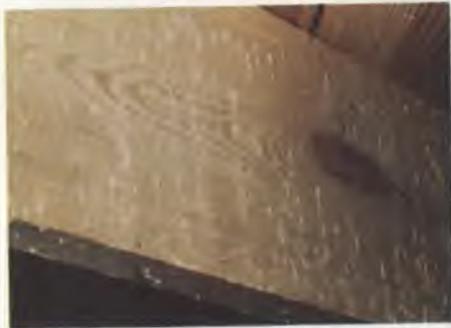
Figure 39. Anobiid damage with powder streaming from insect exit holes

The most common anobiids attack the sapwood of hardwoods and softwoods. They reinfest seasoned wood if environmental conditions are favorable. Attacks often start in poorly heated or ventilated crawl spaces and spread to other parts of the house. They rarely occur in houses on slab foundations. Anobiids range from 1/8 to 1/4 inch in length and are reddish-brown to nearly black. Adult insects are rarely seen. The most obvious sign of infestation is the accumulation of powdery frass and tiny pellets underneath infested wood or streaming from exit holes. The exit holes are round and vary from 1/16 to 1/8 inch in diameter. If there are large numbers of holes and the powder is bright and light-colored like freshly sawed wood, the infestation is both old and active. If all the frass is yellowed and partially caked on the surface where it lies, the infestation has been controlled or has died out naturally. Anobiid tunnels are normally loosely packed with frass and

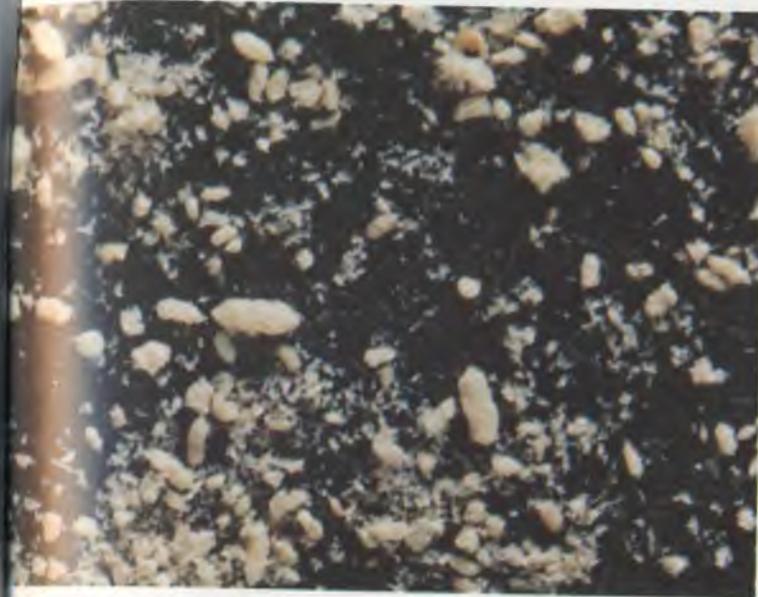
Figure 40. Frass and pellet produced by Anobiid beetle (pellets approximately 1/2 inch long)

pellets. It is normally 10 or more years before the numbers of beetles infesting wood become large enough for their presence to be noted. Control can be achieved by both chemical and non-chemical

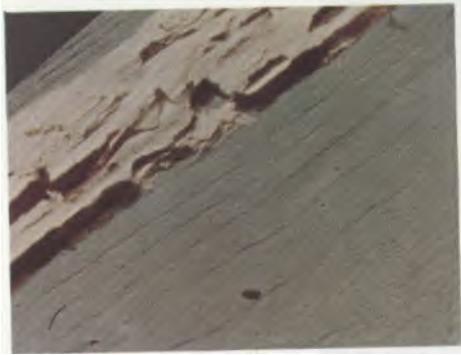
Figure 46. Old house borer damage with oval exit hole and powder-filled galleries in interior of wood

The old house borer attacks only the sapwood of softwoods, primarily pine. It reinfests seasoned wood, unless it is very dry. The old house borer probably ranks next to termites in the frequency with which it occurs in houses in the Middle Atlantic States. The beetle ranges from 5/8 to 1 inch in length, and is brownish-black in color. The first noticeable sign of infestation by the old house borer may be the sound of larvae boring in the wood. They make a rhythmic ticking or rasping sound, much like a mouse gnawing. In severe infestations the frass, which is packed loosely in tunnels, may cause the thin surface layer of the wood to bulge out, giving the wood a blistered look. When adults emerge (3 to 5 years in the South; 5 to 7 years in the North), small piles of frass may appear beneath or on top of infested wood. The exit holes are oval and 1/4 to 3/8 inch in diameter. They may be made through hardwood, plywood, wood siding, trim, sheetrock, paneling, or flooring.

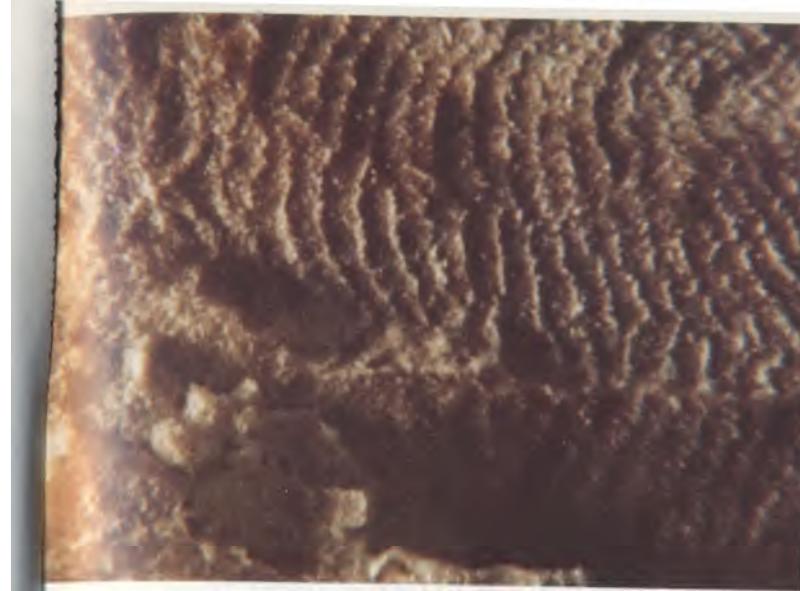
Figure 47. Typical etching wall of old house borer gallery

The frass is composed of very fine powder and tiny blunt-ended pellets. If damage is extreme, the sapwood may be completely reduced to powdery frass with a very thin layer of surface wood. The surfaces of the tunnels have a characteristic rippled pattern like sand over which water

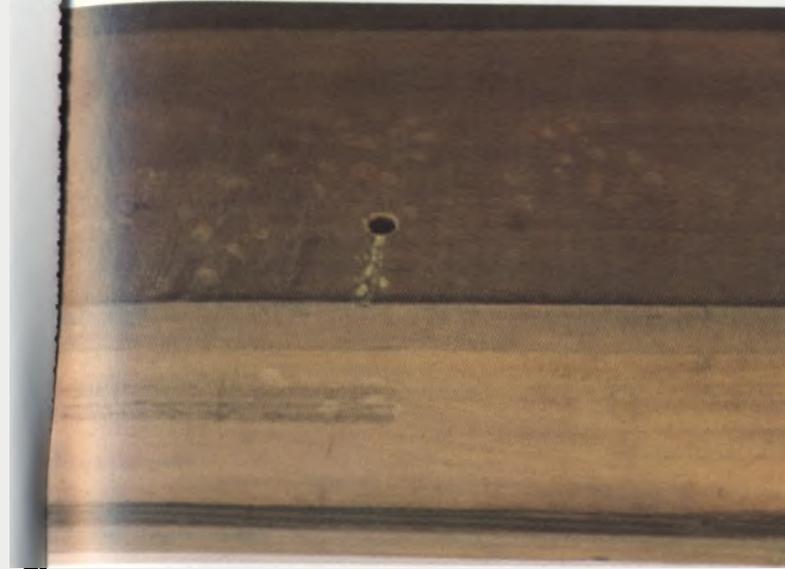
Carpenter bees usually attack soft and easy-to-work woods, such as California redwood, cypress, cedar, and Douglas fir. Bare wood, for example, unfinished siding or roof trim, is preferred. The only external evidence of attack is the entry holes made by the female. These are round and 1/2 inch in diameter. A rather coarse sawdust-like frass may accumulate on surfaces below the entry hole. The frass is usually the color of freshly sawed wood. The presence of carpenter bees in wood sometimes attracts woodpeckers, which increase the damage to the surface of the wood. The carpenter bee tunnels turn at a right angle after extending approximately an inch across the grain of the wood, except when entry is through the end of a board. They then follow

Figure 50. Carpenter bee entry hole (approximate diameter 1/2 inch) with streak of fecal matter below

the grain of the wood in a straight line, sometimes for several feet. The tunnels are smooth-walled. It takes several years of neglect for serious structural failure to occur. However, damaged wood is very unsightly, particularly if woodpeckers have followed the bees. The bees can be

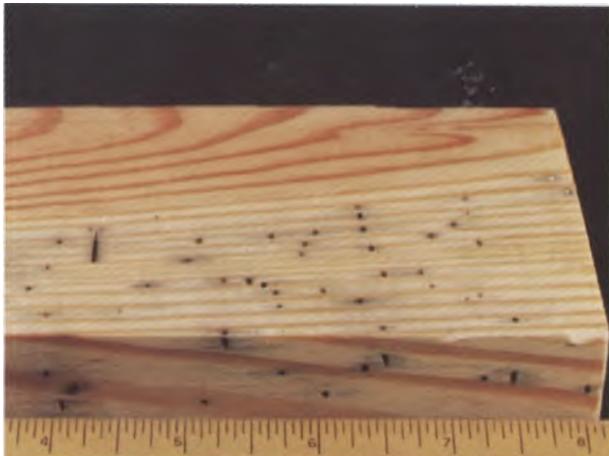
These insects attack unseasoned sapwood and heartwood of softwood and hardwood logs, producing circular bore holes 1/50 to 1/8 inch in diameter. Bore holes do not contain frass, but are frequently stained blue, black, or brown. These insects do not infest seasoned wood.

Figure 51. Ambrosia beetle damage with characteristic empty pin holes surrounded by darkly stained wood

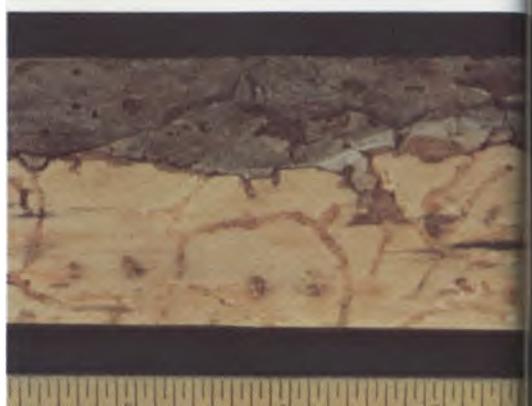
These tunnel at the wood/bark interface and etch the surface of wood immediately below the bark. Beetles left under bark edges on lumber may survive for a year or more as the wood dries. Some brown, gritty frass may fall from circular bore holes in the bark. diameter 1/16 to 3/32 inch. These insects do not infest wood.

Figure 52. Bark beetle damage at bark/wood interface

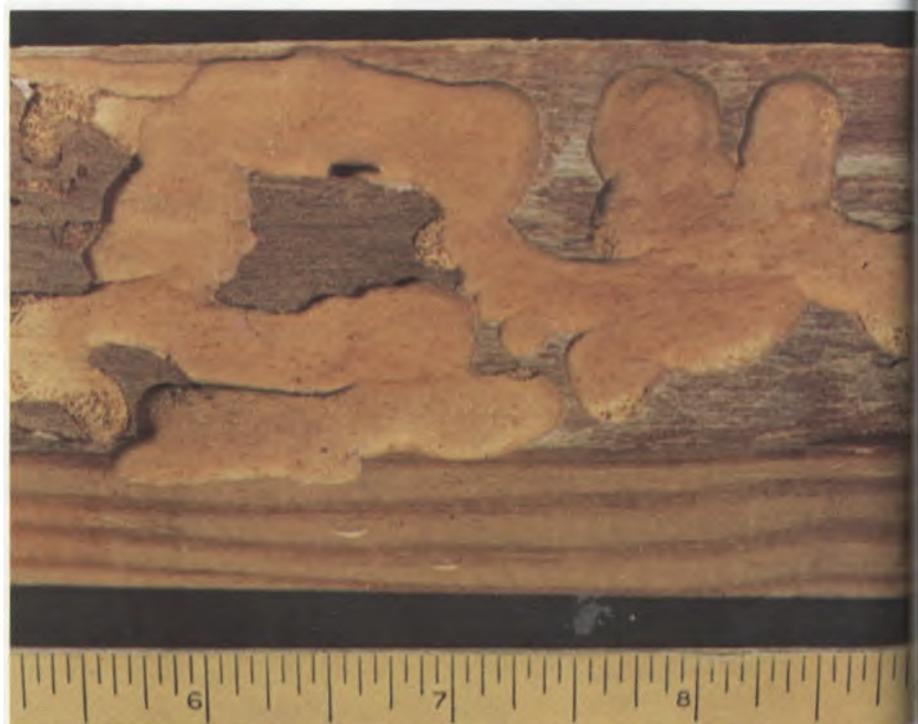
Figure 55. Flat-headed borer damage

They attack sapwood and heartwood of softwoods and hardwoods. Exit holes are oval, with the long diameter 1/8 to 1/2 inch. Wood damaged by flat-headed borers is generally sawed after damage has occurred, so tunnels are exposed on the surface of infested wood. Tunnels are packed with sawdust-like borings and pellets, and tunnel walls are covered with fine transverse lines somewhat similar to some round-headed borers. However, the tunnels are much more flattened. The golden buprestid is one species of flat-headed borer which occurs occasionally in the Rocky Mountain and Pacific Coast States. It produces an oval exit hole
